Fortress Machinery Appraisals & Consulting Inc.

Unidentifiable Example Asset Appraisals for Illustration Purposes Only

Asset Description for: Example Appraisals

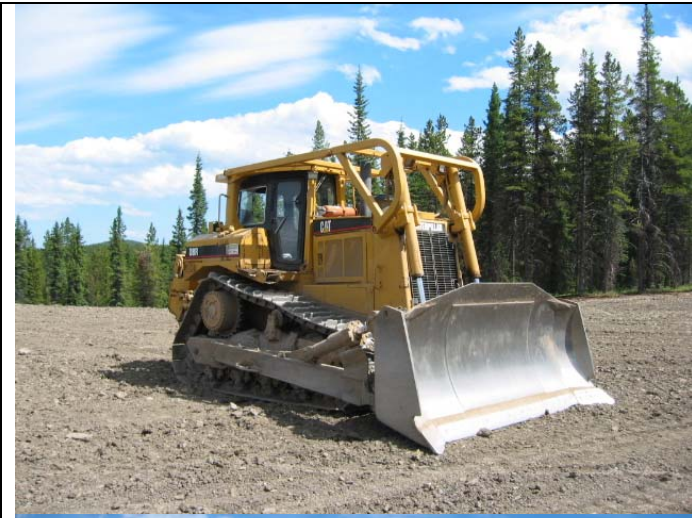
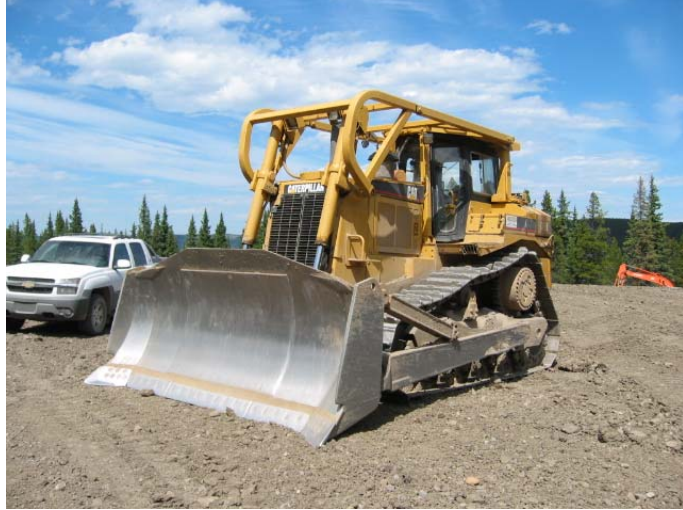
Verified Year: 1997
Make: Caterpillar
Model: D8R Crawler Tractor
Condition: Good
Serial Number: **7XM00000**
Unit: 0000

Description: 3,995 Hours, Caterpillar 3406B diesel engine, s/n 00000, 305 HP with emergency engine shutdown device, powershift transmission and differential steering. EROPS cab with climate control. 24" extreme service track shoes on eight roller track frames. Heavy duty radiator guard, oilfield guarding package, engine side guards, battery box and hydraulic tank guards, transmission guard and fuel tank guard. Caterpillar 8SU (semi universal) bulldozer blade with single tilt cylinder and spill plate. Caterpillar #8 single shank adjustable ripper with hydraulic pin puller, S/N 1FH00000 and deep ripping shank. Fire and safety equipment.

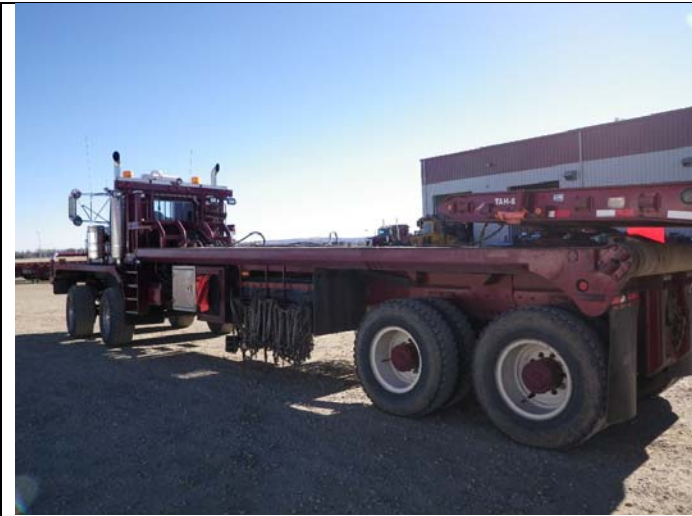
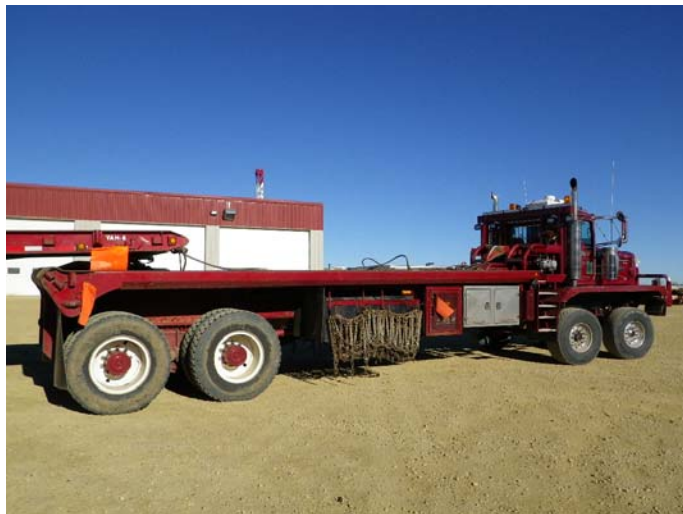
Steel headache rack, steps and toolboxes. Fire and safety equipment. Alberta CVIP certification date.

Verified Year: 2007
Make: Kenworth
Model: C500B Tandem -Tandem Planetary Bed Truck
Condition: Very Good
Serial Number:
1NKCX4TX87R000000
Unit #: 0000

Description: 5,891 Hours, 196,297 KM, Cummins ISX- 450 diesel engine, 450 HP, serial number 00000000, emergency shutdown device, engine brake and Alison 4500 RDS automatic five speed transmission. Tandem 36,000 LB front axles with 72" axle spacing, SISU FR2P-32-S planetary 65,000 LB rear axles, equalizer suspension, 60" axle spacing and 350" wheelbase with setback. Air conditioning, stereo and axle lockers. Front aluminum budd wheels on 445/65R x 22.5 tires and rear heavy duty steel wheels on 1200 x 24 tires. 9' 6" x 28' heavy duty oilfield bed, poles, pole kickers, hideaway 5th wheel, rear live roll and tail skirt. Braden hydraulic main and auxiliary winches. Heavy duty oilfield bumper.

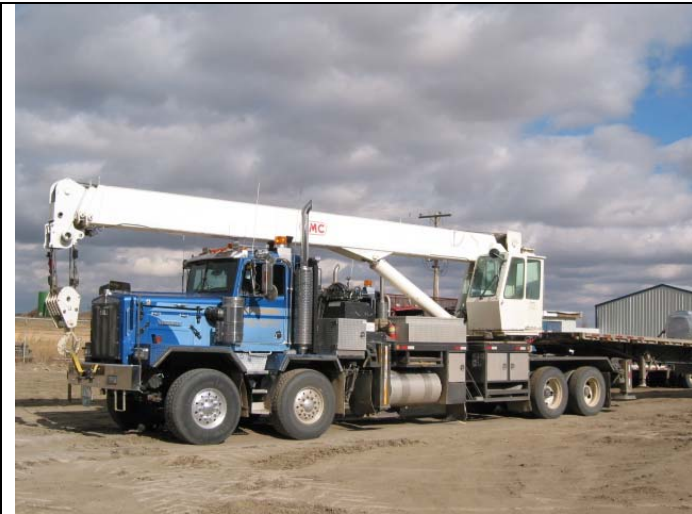
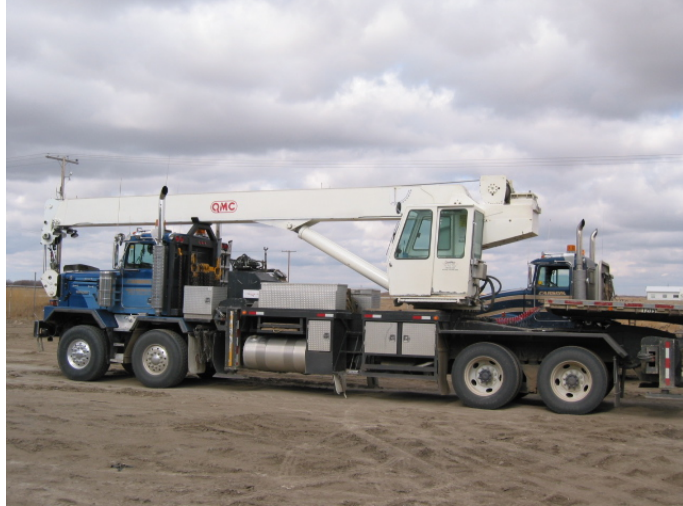
Verified Year: 2001
Make: Kenworth
Model: C550B Tandem-Tandem
Picker Tractor
Condition: Good
Serial Number:
1XKCP6EX61S000000
Unit #: 0000

Description: 126,916 KM, 5,822 Hours, Cummins N-14 diesel engine, s/n 00000000, 460 HP, emergency shutdown device and RTLO 18918B - 18 speed transmission. Front tandem 36,000 LB axles with 72" axle spacing and rear tandem RT46 160P - 46,000 LB axles with 55" axle spacing with 315" wheelbase. Front aluminum budd wheels on 445/65R x 22.5 tires, rear steel budd wheels on 11R x 24.5 tires. Aluminum headache rack, frame deck, steps, toolboxes, air slide 5th wheel, fenders and frame ramps. 2001 QMC Model 84705 42 Ton capacity hydraulic truck crane, serial 1012000000, operator cab, heater and four hydraulic outriggers. Kova Engineering certificate date. Saskatchewan CVIP certification date.

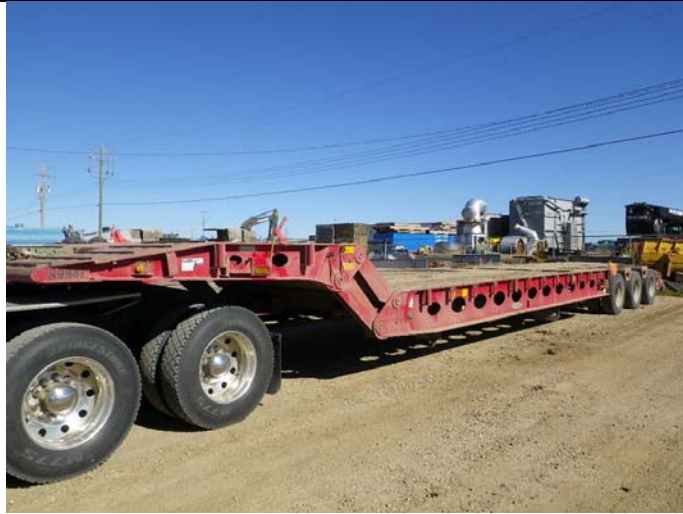
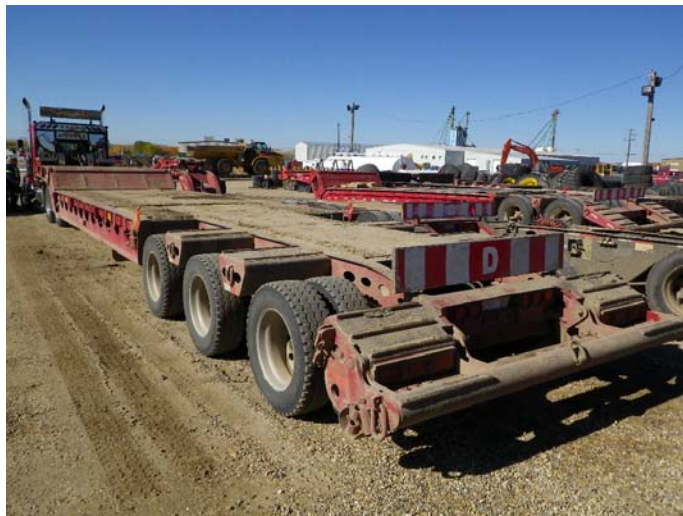
Verified Year: 2008
Make: Peerless
Model: Tridem Folding Neck
Lowboy Trailer
Condition: Very Good
Serial Number:
2PLG053378BK00000
Unit #: 0000

Description:
Model LB45-SDLRSSW-3A
45 Ton folding neck tridem
lowboy trailer with Hendrickson
air suspension, 60" axle spacing
and aluminum budd wheels.
10' x 25' working deck, center
air assisted kicker roll and flip
over rear beaver tail ramp and
live roll combination. Folding
dolly legs, front and rear swing
out lights. Alberta CVIP
certification date.

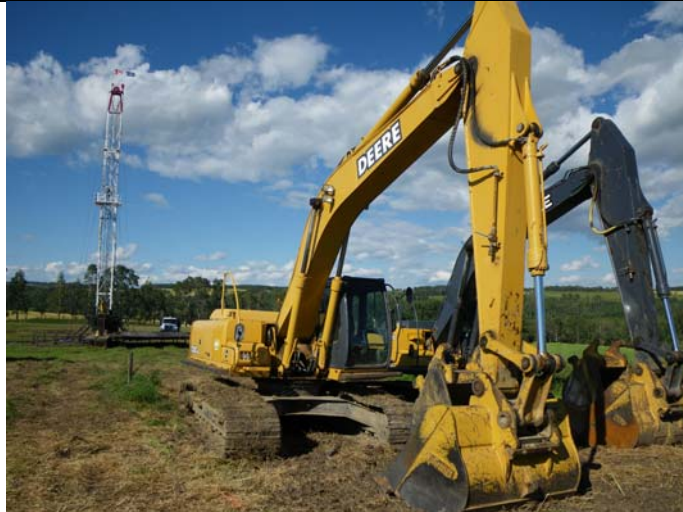
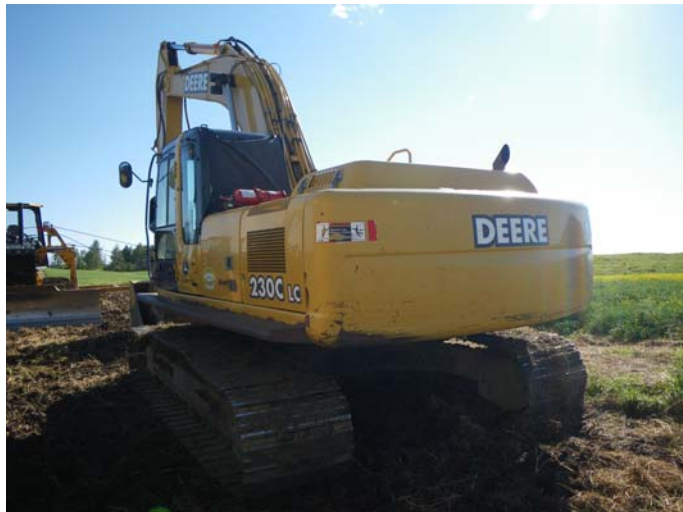
Verified Year: 2005
Make: John Deere
Model: 230C LC Hydraulic
Excavator
Condition: Good
Serial Number:
FF230CX000000
Unit #: 0000

Description: 6,916 Hours, John Deere diesel engine, emergency shutdown device, s/n 000000 and hydrostatic drive. Operator cab with climate control and heavy duty catwalks. 31.5" triple grouser track shoes on nine roller track frames. Reach boom, 12' stick, wedge type quick attachment device, 66" cleanup bucket with bolt on cutting edge and 36" digging bucket with teeth. Auxiliary valve and lines. Webasto diesel auxiliary engine heater. Fire and safety equipment.

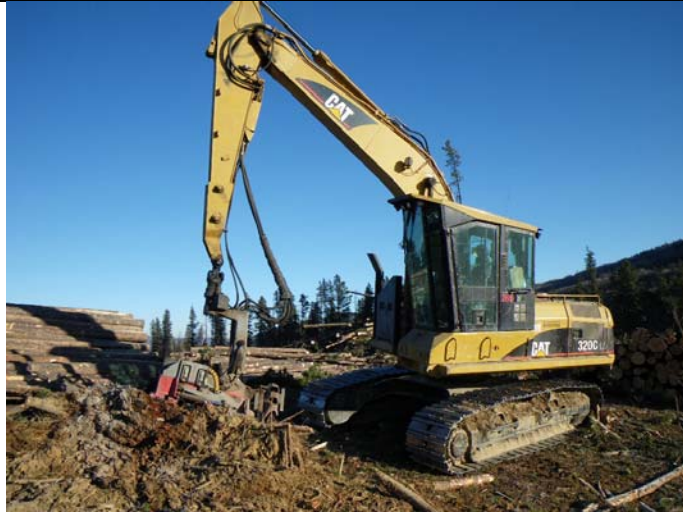
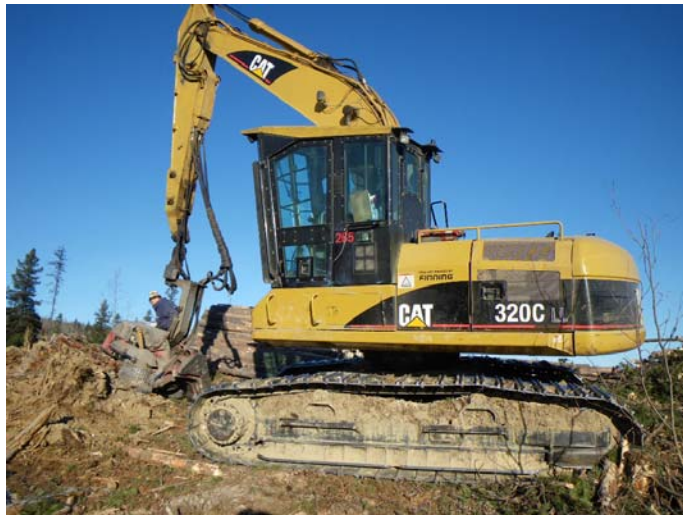
Verified Year: 2007
Make: Caterpillar
Model: 320C LL Delimber Processor
Condition: Good
Serial Number:
CAT0320CTSAH00000
Unit #: 0000

Description: 11,519 Hours, Caterpillar 3066 diesel engine and hydrostatic drive. Purpose built forestry EROPS cab with climate control, 12" cab riser and heavy duty catwalks. 28" center punched double grouser track shoes on nine roller track frames with long track roller guards. Forestry guarding, reach boom, 11' stick and Logmax 7000 delimeter processor head, serial number **7000-0000** and Logmax electronic measuring device with printer. Fire suppression system and safety equipment.

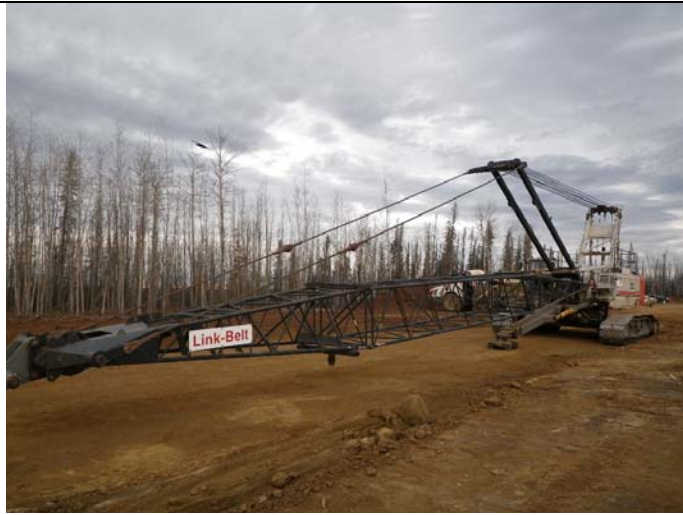
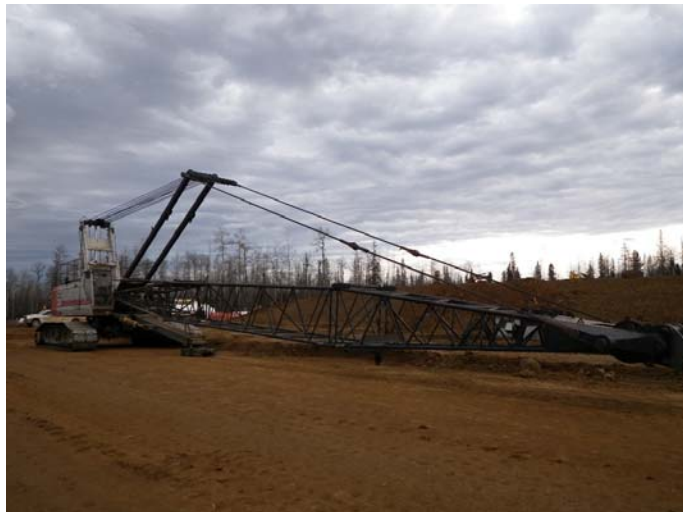
Verified Year: 2002
Make: Link Belt
Model: L218H II - 110 Ton
Crawler Crane
Condition: Good
Serial Number:
J2JO-0000
Unit #: 0000

Description: 2,399 Hours, Cummins 8.3 L diesel engine, serial number 00000000, 260 HP, emergency shutdown device and hydrostatic drive. Operator cab with air conditioning and heater. 35" flat type track shoes on eleven roller track frames. Two Pullmaster main winches and Pullmaster M25 auxiliary winch. Block and ball, hydraulic carbody jacks and self erect counterweights. 110 Ton lift capacity crane with Boom Butt Jib, serial number **L0000000**, Boom Intermediate Jib, serial number **L0000000** and Boom Tip Jib, serial number **L0000000**. RED Associates Engineering certification date. Fire and safety equipment.
